# **Single-Event Effect Report for EPC Series eGaN FETs: EPC1001, EPC1010, EPC1014, EPC1012**

Leif Scheick, Ph.D.  
Jet Propulsion Laboratory  
Pasadena, California

JPL Publication 13-4 2/13

NASA Electronic Parts and Packaging (NEPP) Program  
Office of Safety and Mission Assurance

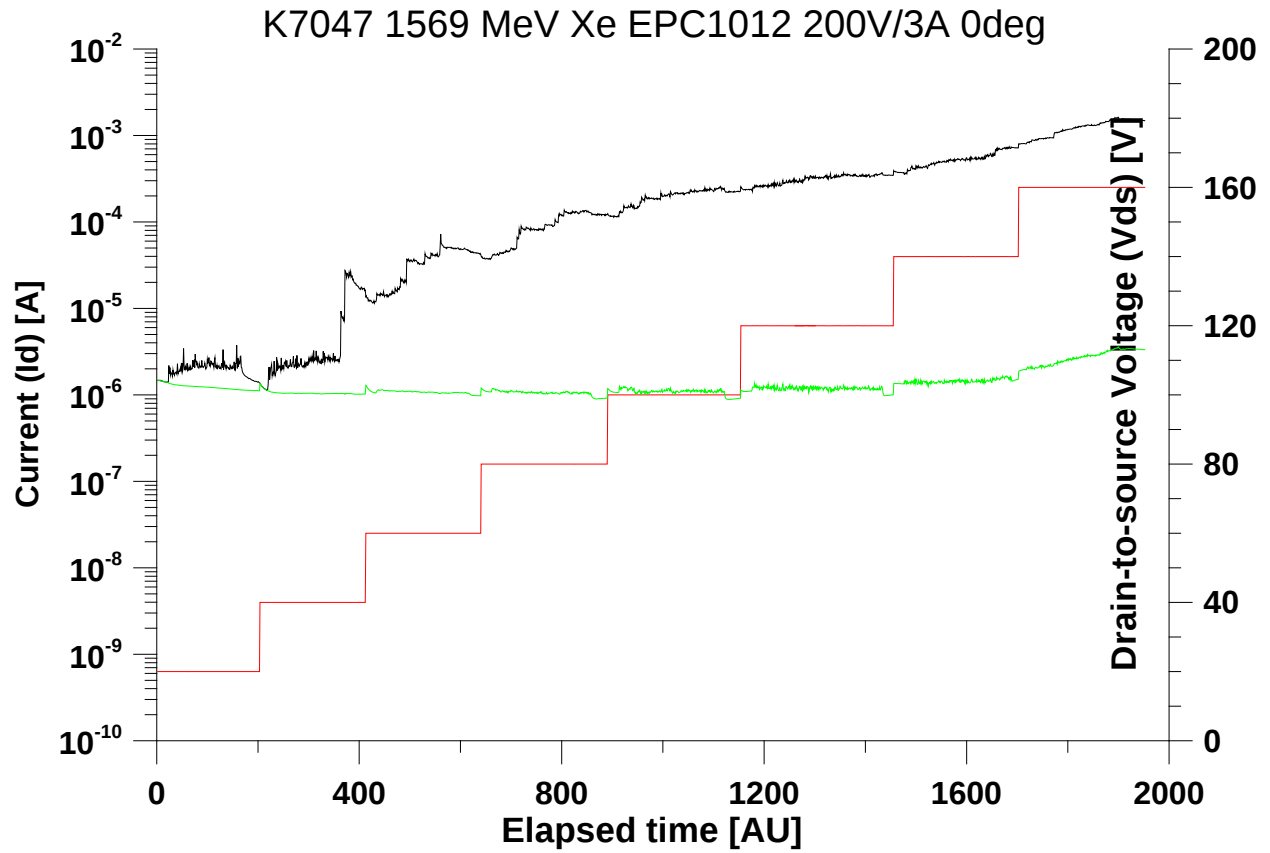
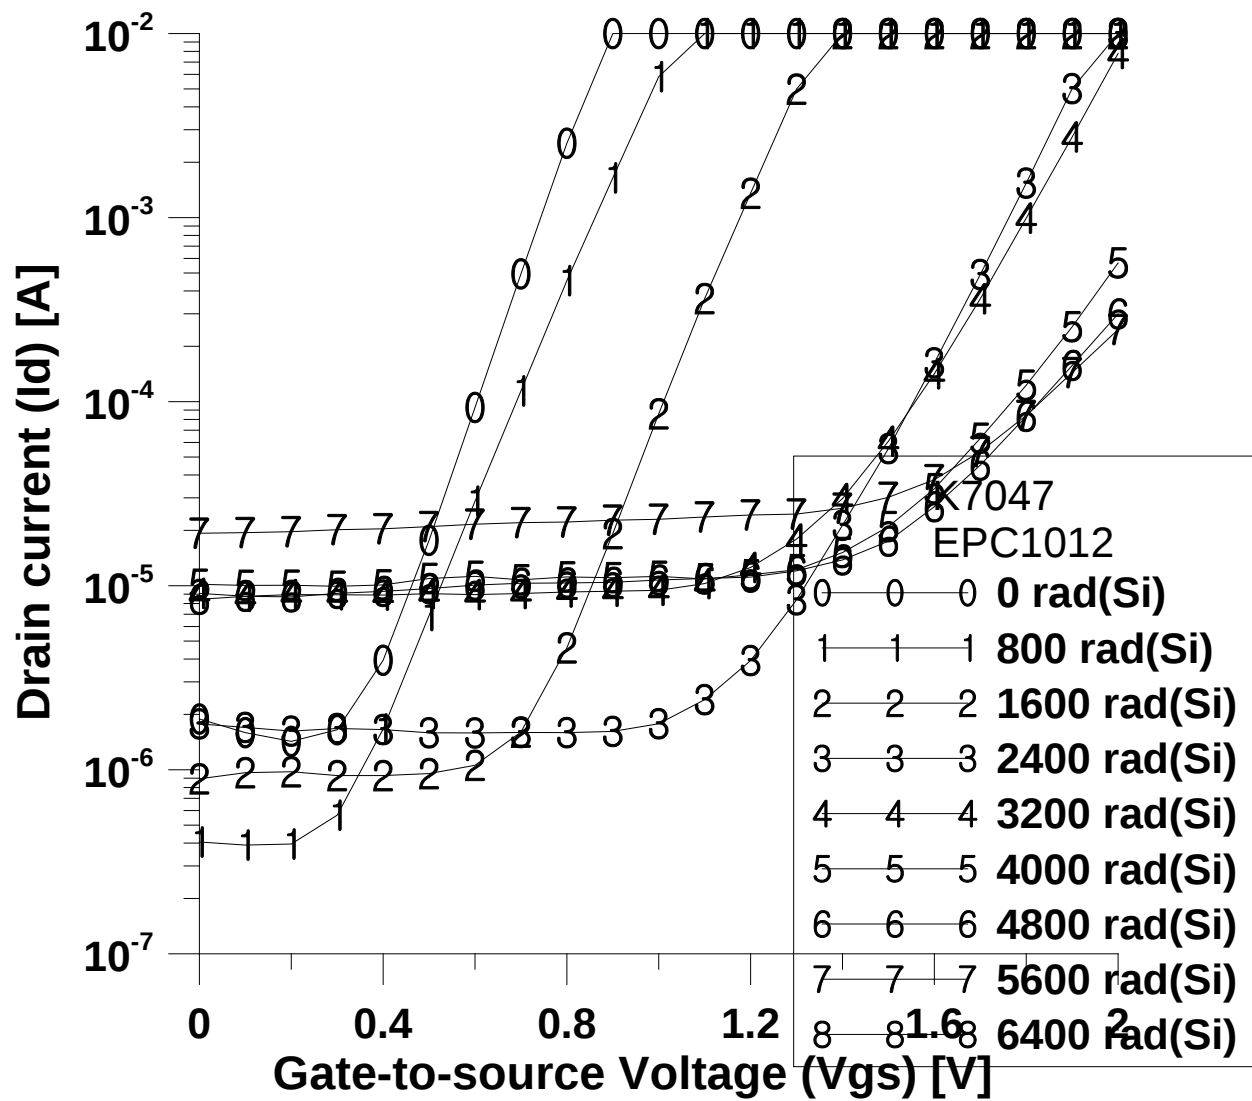
Fig. 9.15 and 9.16 present part K7047, EPC1012.

**Figure 1.1-1.** Heavy ion response of the EPC1012 200V/3A. Ion flux was  $3\text{E}4 \text{ cm}^{-2}\text{-s}^{-1}$ . Red line is drain voltage; gate voltage is zero volts. Black line is drain current and green line is gate current.

Figure 1.1-1. Effect of heavy ion radiation on the transfer curve K7047. Drain voltage was 10 V.

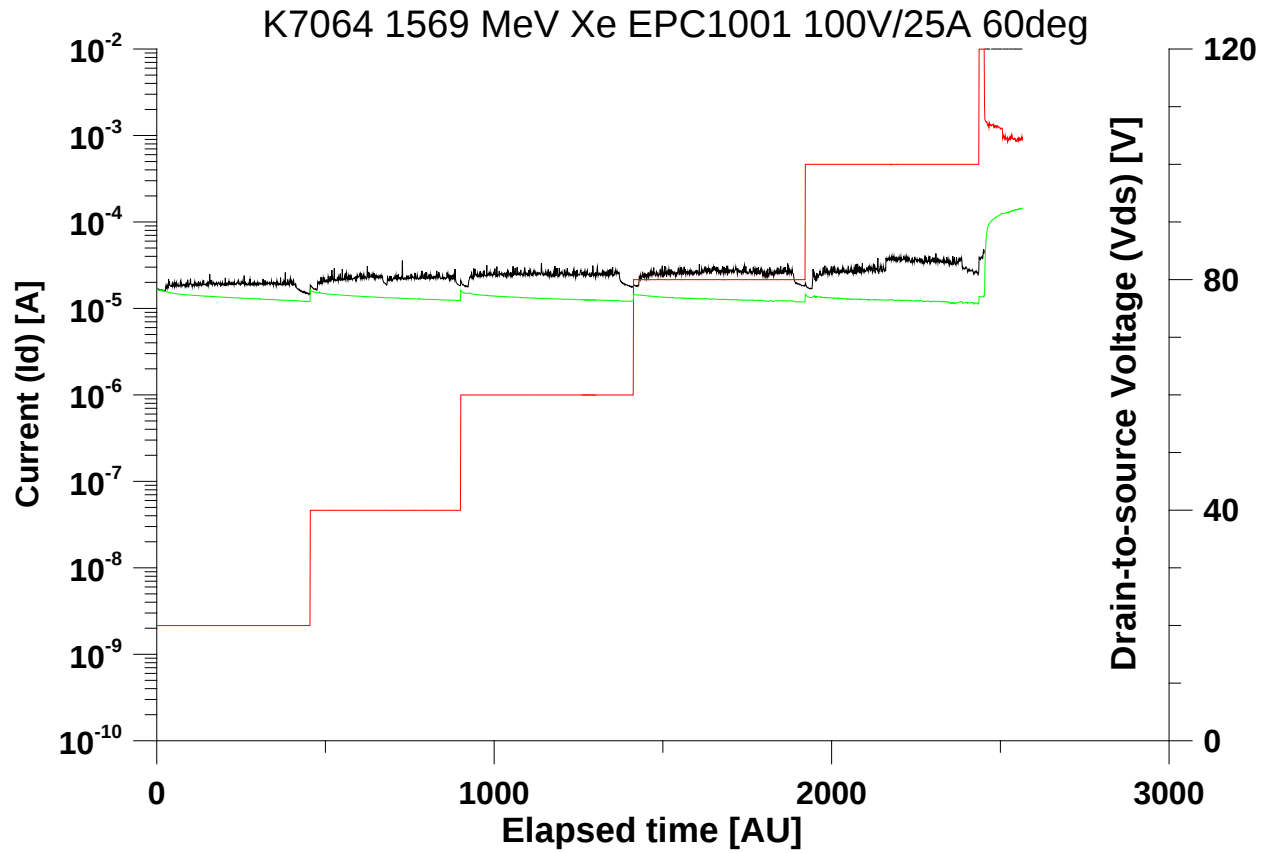
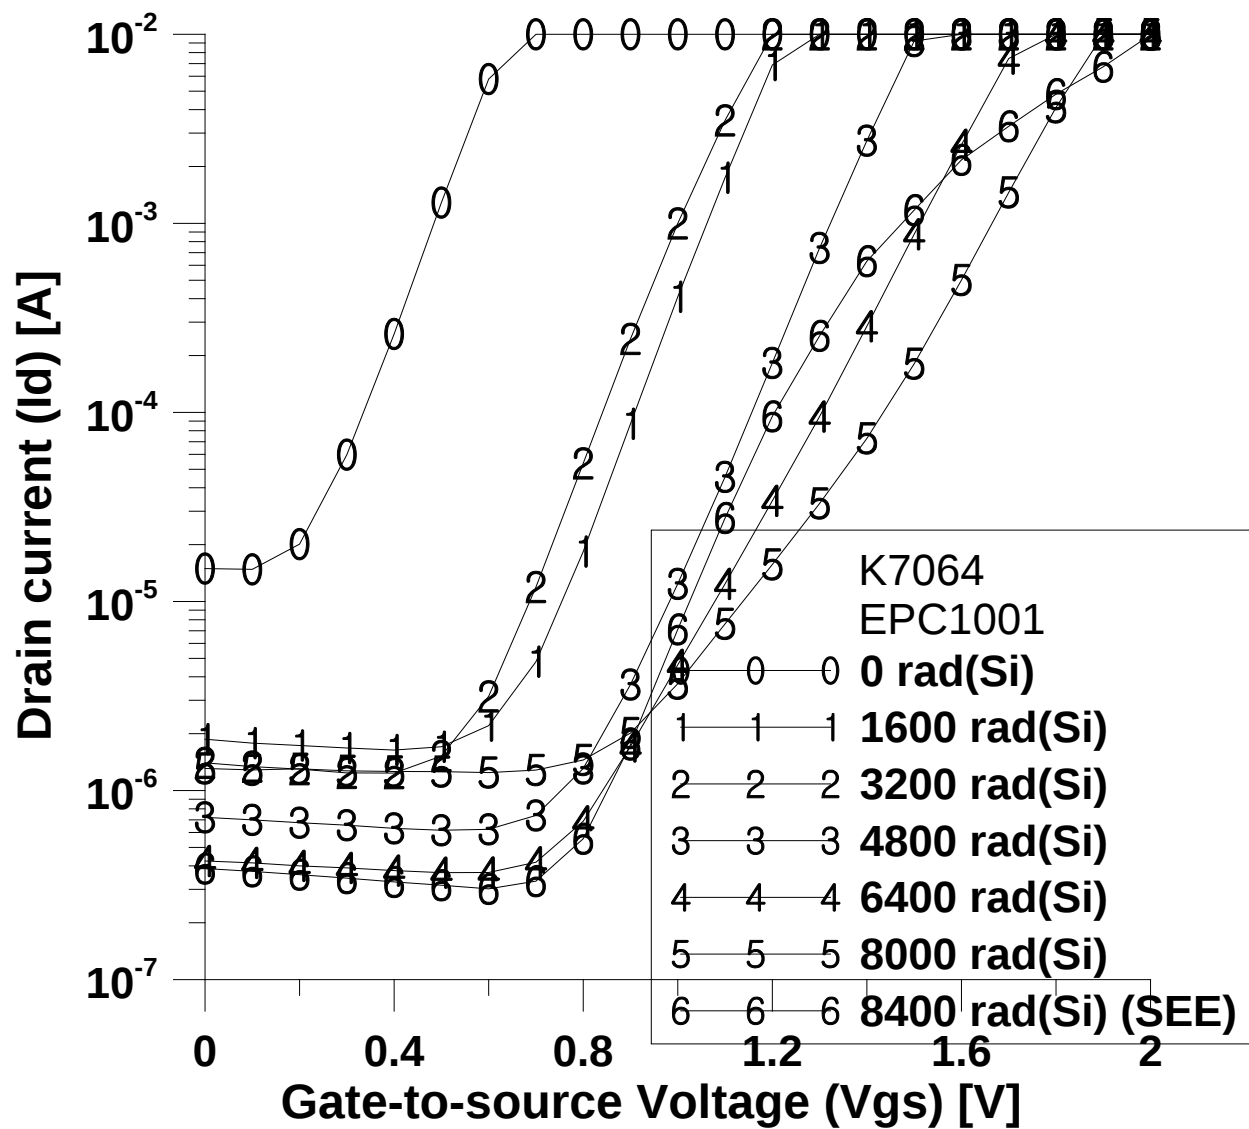
Fig. 9.17 and 9.18 present part K7064, EPC1001. Despite no drain leakage, the  $V_{th}$  and Gm are affected.

**Figure 1.1-1.** Heavy ion response of the EPC1001 100V/25A 60deg. Ion flux was  $3E4 \text{ cm}^{-2}\text{-s}^{-1}$ . Red line is drain voltage; gate voltage is zero volts. Black line is drain current and green line is gate current.

Figure 1.1-1. Effect of heavy ion radiation on the transfer curve K7064. Drain voltage was 10 V.

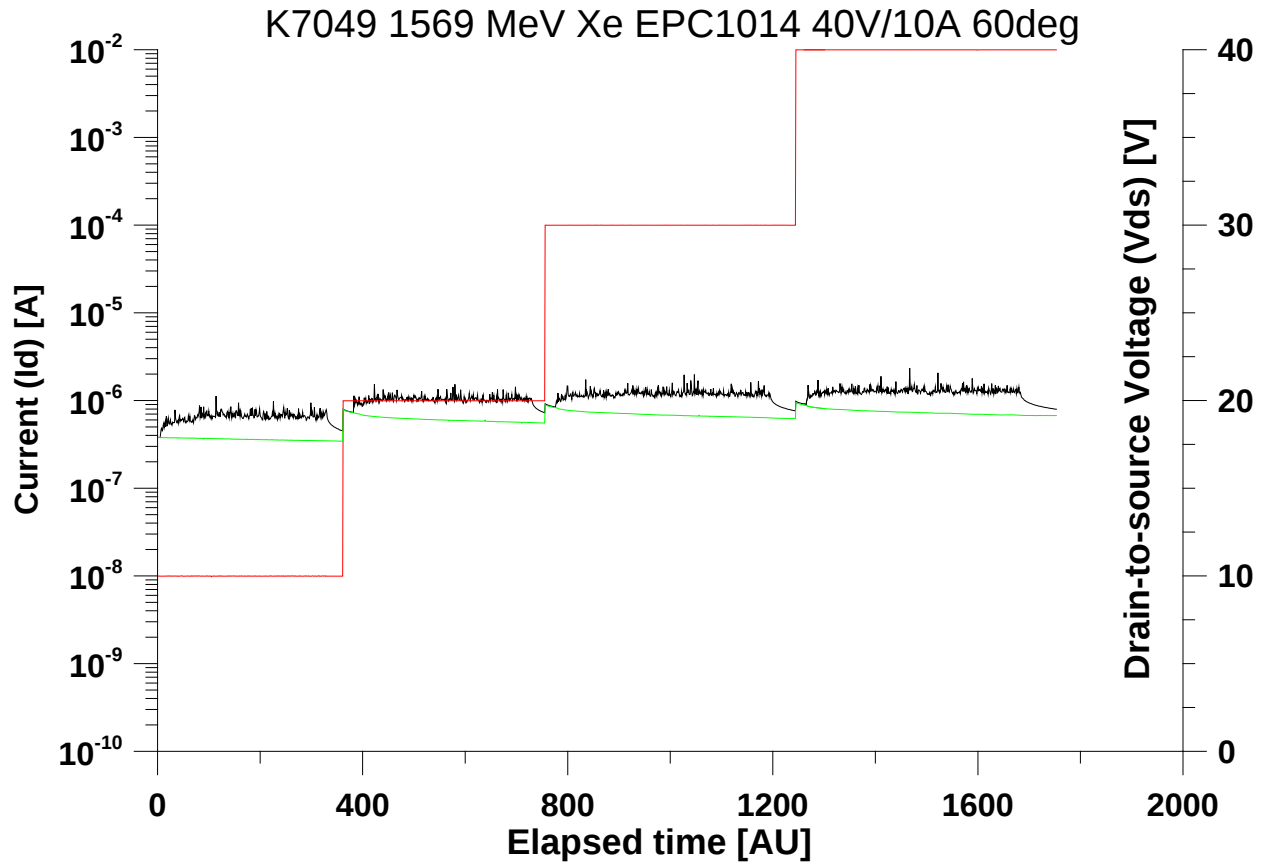
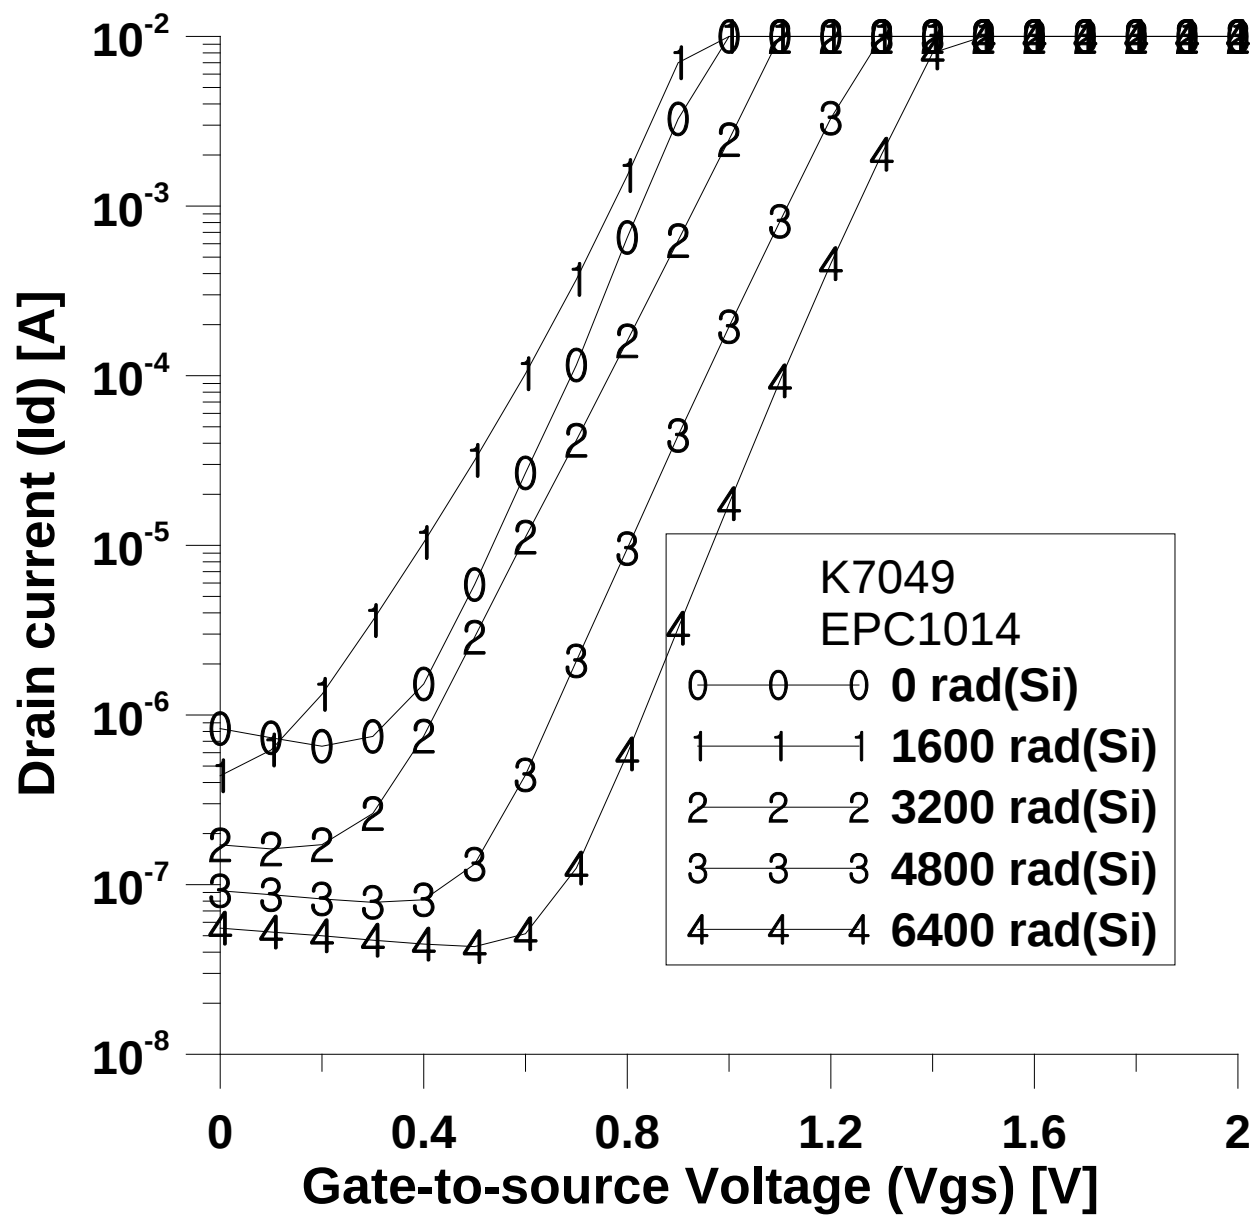
Fig. 9.19 and 9.20 present part K7049, EPC1014. Despite no drain leakage, the  $V_{th}$  and Gm are affected.

Figure 1.1-1. Heavy ion response of the EPC1014 40V/10A 60deg. Ion flux was  $3E4 \text{ cm}^{-2}\text{s}^{-1}$ . Red line is drain voltage; gate voltage is zero volts. Black line is drain current and green line is gate current.

Figure 1.1-1. Effect of heavy ion radiation on the transfer curve K7049. Drain voltage was 10 V.

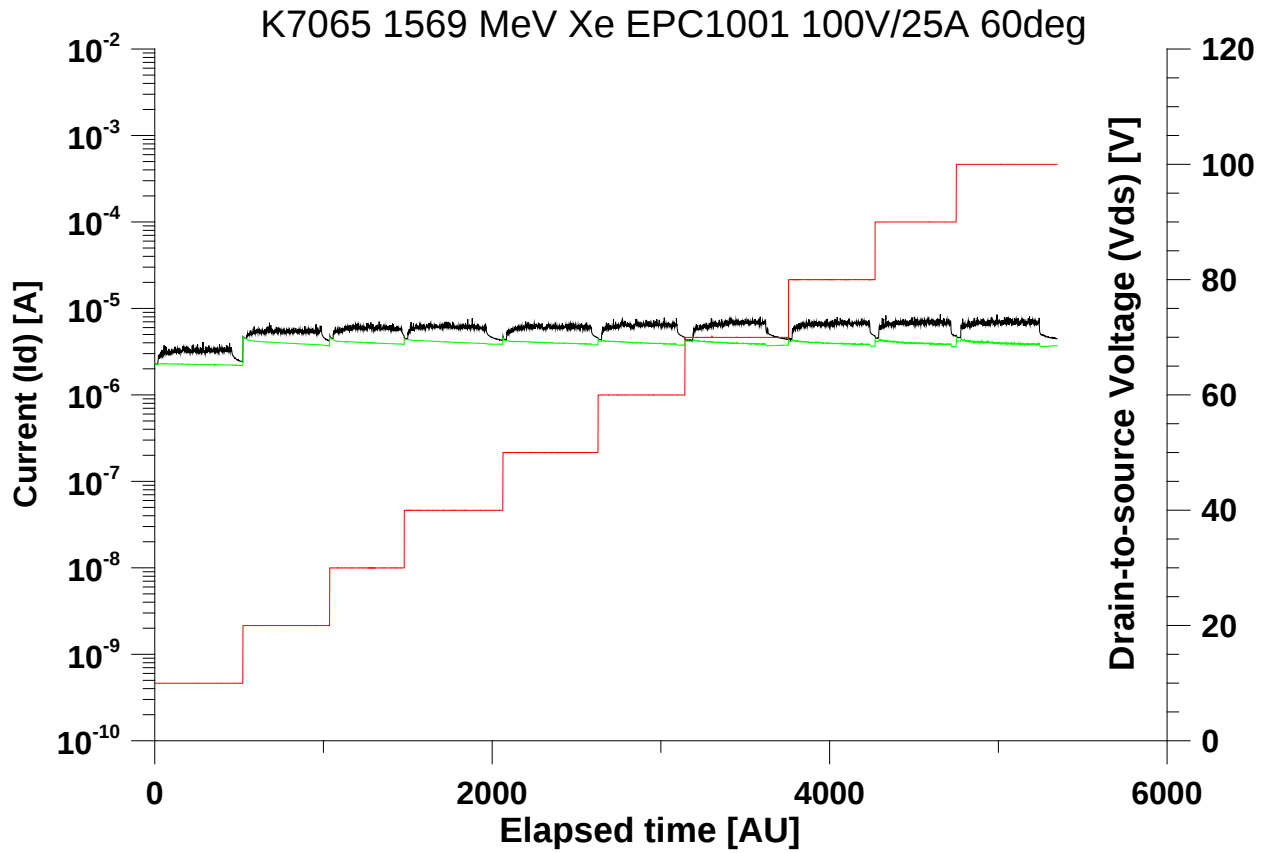
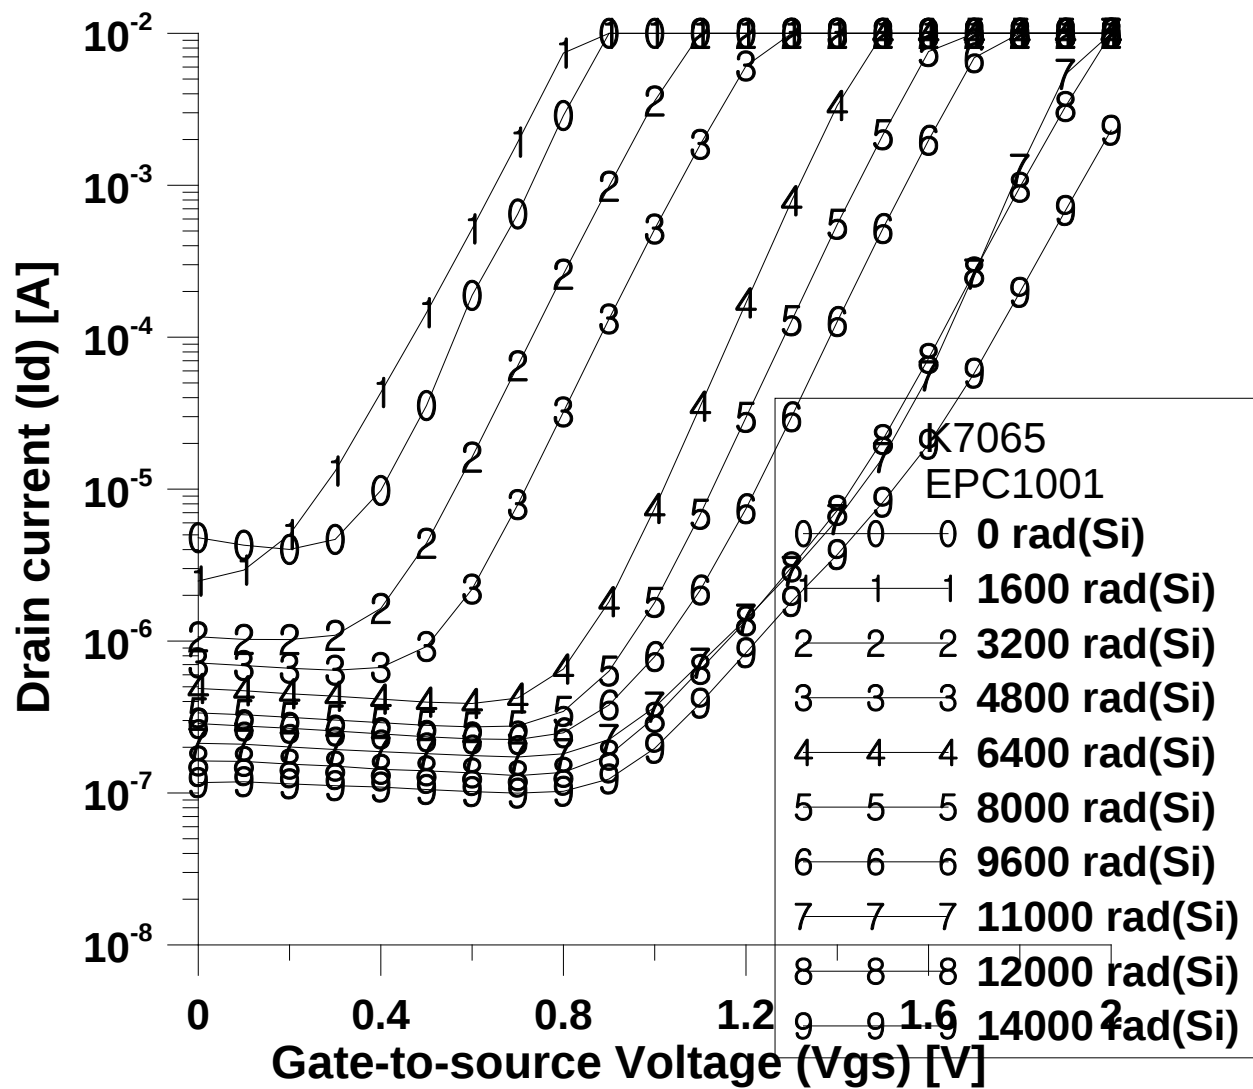
Fig. 9.21 and 9.22 present part K7065, EPC1001. Despite no drain leakage, the  $V_{th}$  and Gm are affected.

**Figure 1.1-1.** Heavy ion response of the EPC1001 100V/25A 60deg. Ion flux was  $3E4 \text{ cm}^{-2}\text{-s}^{-1}$ . Red line is drain voltage; gate voltage is zero volts. Black line is drain current and green line is gate current.

Figure 1.1-1. Effect of heavy ion radiation on the transfer curve K7065. Drain voltage was 10 V.

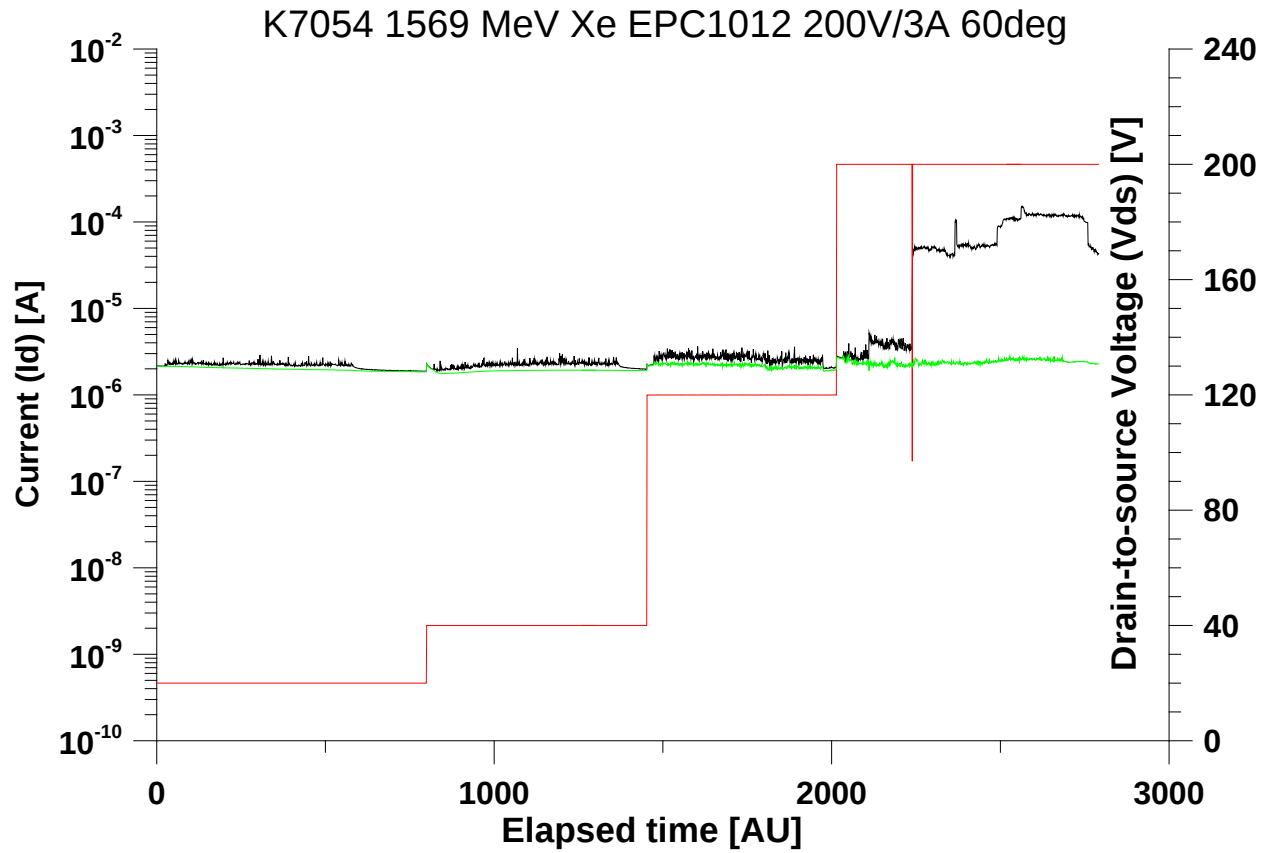
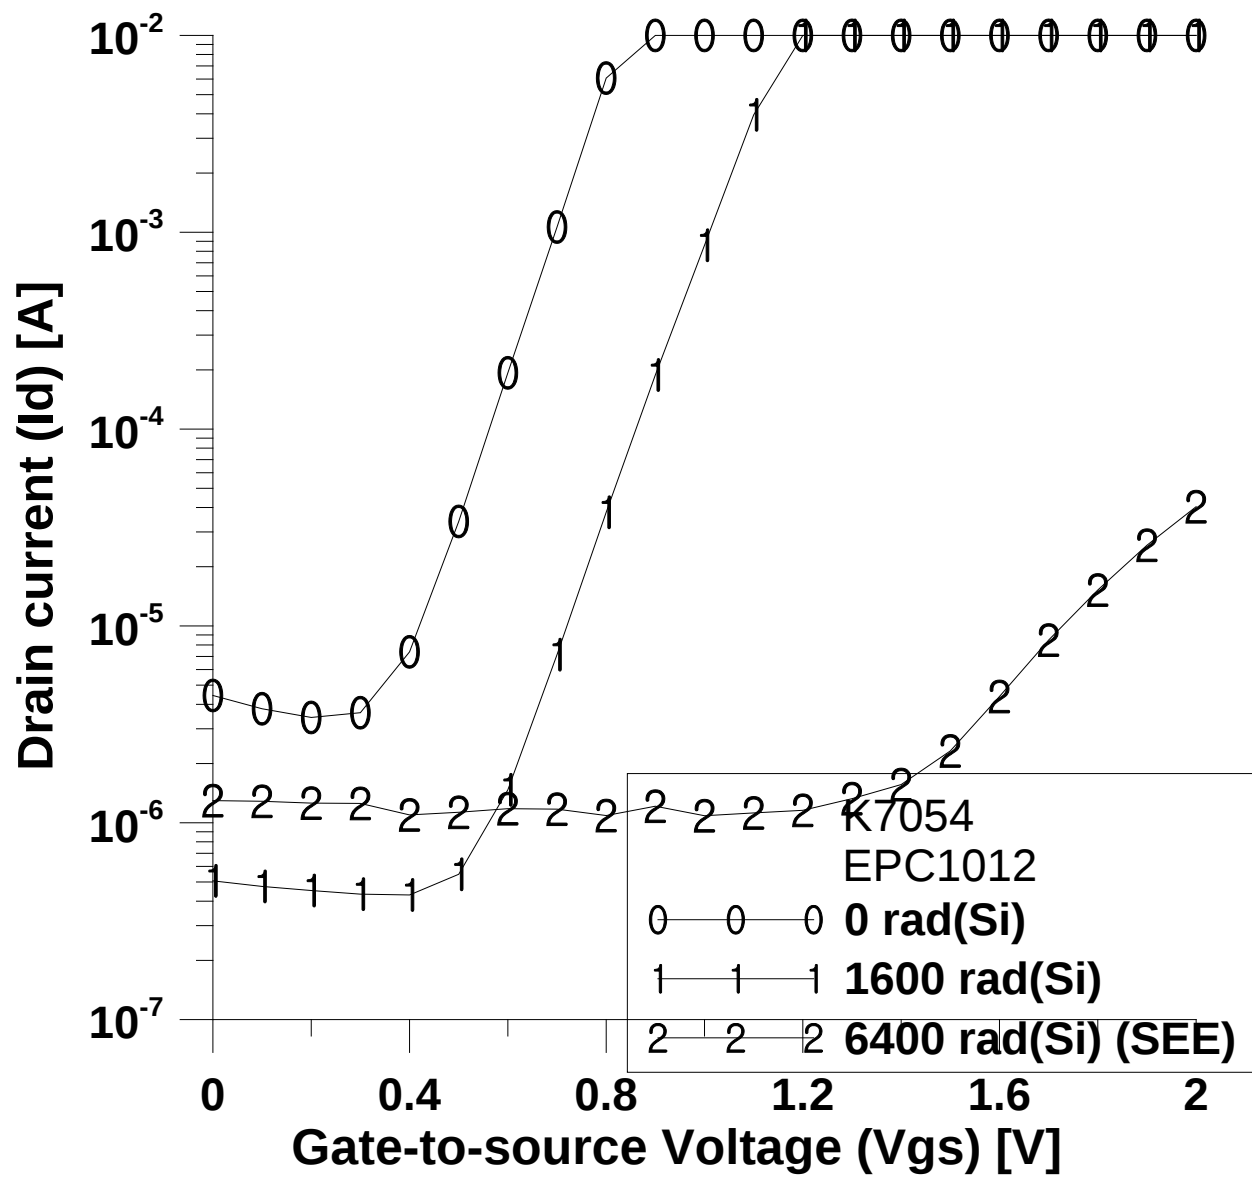
Fig. 9.23 and 9.24 present part K7054, EPC1012. Despite no drain leakage, the  $V_{th}$  and Gm are affected. These data were taken at aggressive voltage steps to conserve machine time. The SEE results may overestimate the effect

**Figure 1.1-1.** Heavy ion response of the EPC1012 200V/3A 60deg. Ion flux was  $3E4 \text{ cm}^{-2}\text{-s}^{-1}$ . Red line is drain voltage; gate voltage is zero volts. Black line is drain current and green line is gate current.

Figure 1.1-1. Effect of heavy ion radiation on the transfer curve K7054. Drain voltage was 10 V.
